**Re: ROS Rack Repair Stub Column Testing
Packer Engineering Project No.: 502713**

Packer Engineering was retained to perform stub column testing for ROS Rack Repair. The purpose of this testing was to verify and quantify the strength of the rack columns after they had been damaged and then repaired. All testing was performed in accordance with ANSI MH16.1:2008, Part VIII of the 1996 AISI Cold-Formed Steel Design Manual, and FEM 10.2.02.

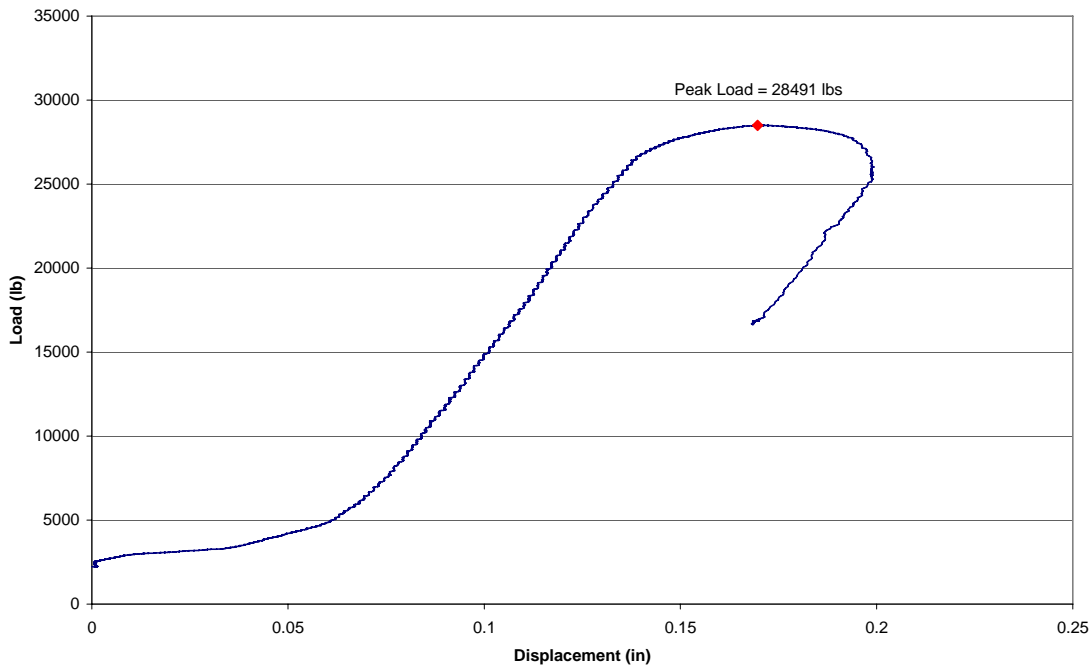
Chart 1 – Sample 1 Compression Test

During the compression loading of the rack sections the peak load was measured when the load versus displacement curve leveled off (see Chart 1). Peak loading was recorded the center area of the sections distorted and began to buckle (Figure 10).

The next phase of testing was to compare the compression testing of undamaged sections of rack, to damaged and repaired sections, with some sections receiving up to three (3) repairs, also using FEM 10.2.02 section 5.3.3. A higher capacity Baldwin Universal Test Machine was used to load the rack sections longitudinally (Figure 8). A MTS load cell swivel assembly was used at the lower end of the rack to account for any lateral loading or lack of squareness (Figure 9). Undamaged sections had compressive loads ranging from 29,300 lbs (13,290 kg) to 32,649 lbs (14,809 kg). Damaged and repaired sections ranged from 28,491 lbs (12,923 kg) to 31,777 lbs (14,414 kg). Ref. Table 1 for a summary of the data.

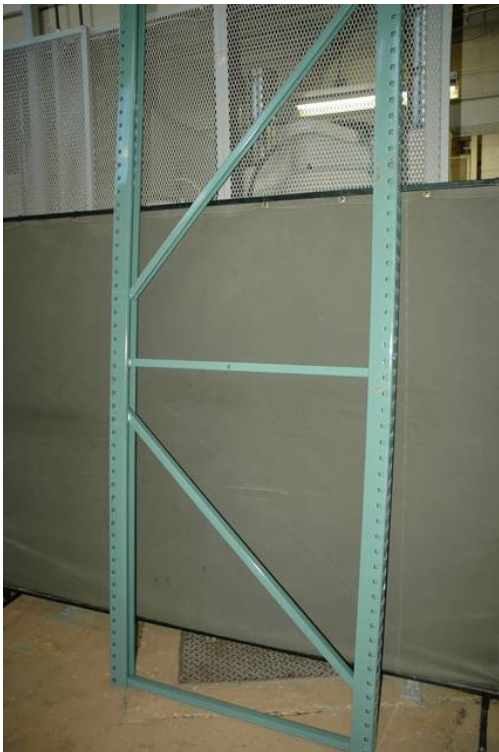
Figure 1

ROS Rack Repair arranged for direct shipment from Interlake/Mecalux to Packer Engineering of (3) complete Interack 30 Welded F Punch Frame sections (48" maximum unsupported length). The model numbers **075** (13 gauge, 0.090" thick) and **077** (12 gauge, 0.105" thick) sections were used (see Figures 1-4). From material published by Interlake/Mecalux, the maximum total rack capacities are 30,600 lbs for the 075 model, and 35,200 lbs for the 077. Since these values are for complete rack sections, individual leg load capacities would be 15,300 and 17,600 lbs, respectively.

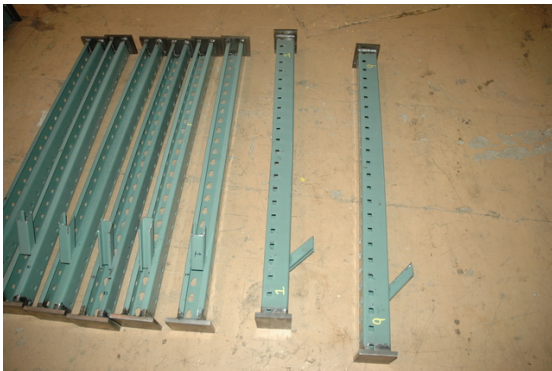
Figure 5

Packer Engineering cut twelve (12) equivalent sections of rack column supports for testing per FEM 10.2.02 section 5.3.2. These sections were to be 1200mm long, and within 1mm for overall squareness (+/- 0.5mm). Steel plates (approx. 100mm square and 9.5mm (3/8") thick), were welded onto each end for support during testing (Figure 5). The ends of the cut sections of rack were milled to be within specification requirements.

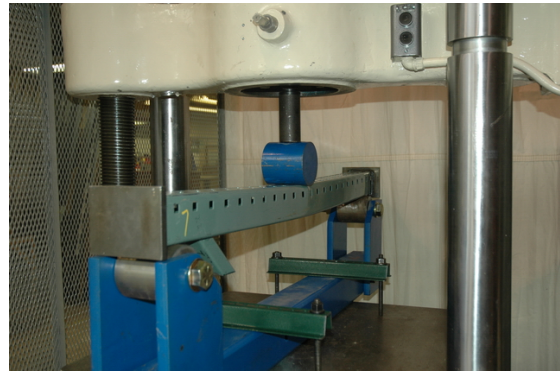
Figure 6

The next step in this project was to damage nine (9) of the twelve (12) rack sections, according to FEM 10.2.02 section 5.3.3. A Baldwin Universal Test Machine was used to damage the rack sections. The rack sections were supported on both ends horizontally by a fixture, and loaded in the center with a 100mm diameter cylinder (Figure 6). Loads input into the sections ranged from 3200 to 3400 lbs (1451 to 1542 kg), but dropped approximately 10% by the third damage load (Figure 7). It should be noted that each damage run used the same location. Table 1 summarizes the load data for each sample and trial. There was no discernable difference in the data by model for the samples tested.
